Northern Rail Extension Project Phase 1

Piledriver Slough 2016 Monitoring Report

December 31, 2016

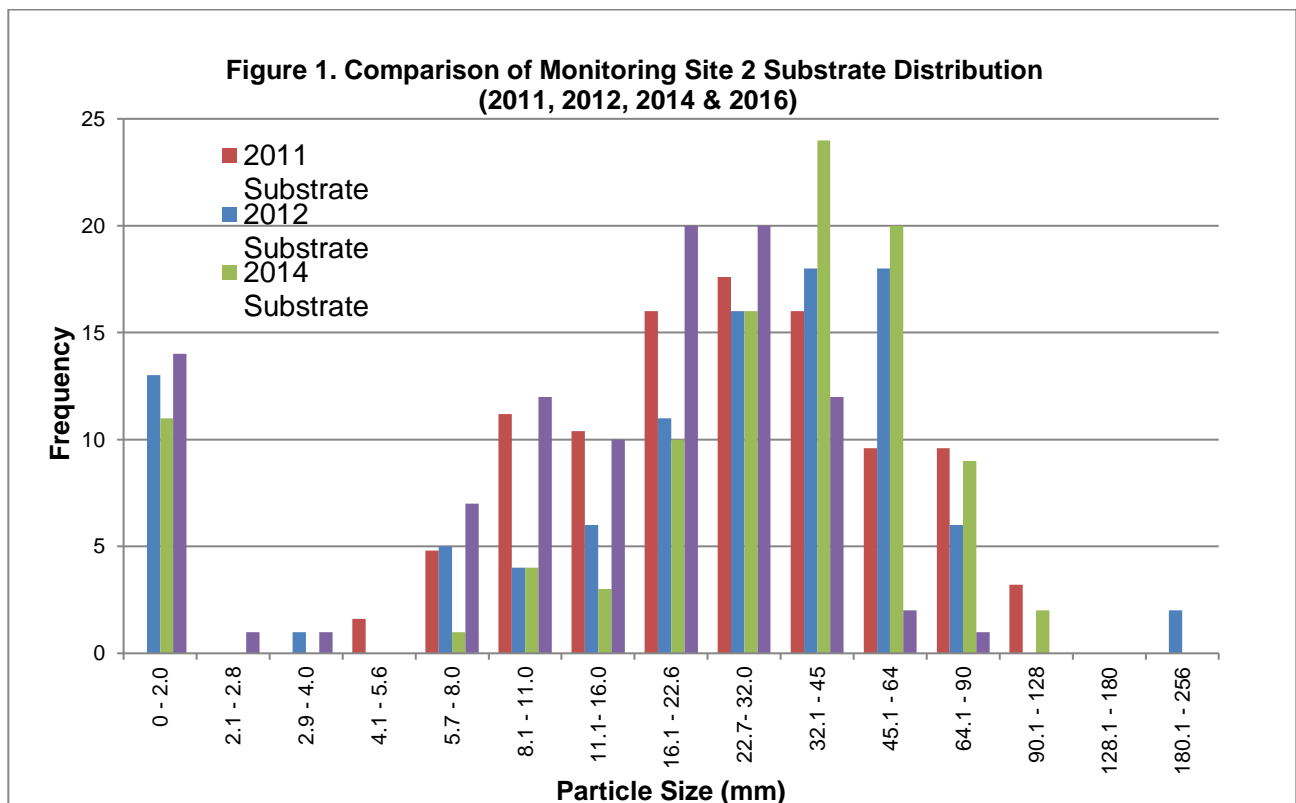
Substrate size distribution for Monitoring Site 2 is shown below in Figure 1.

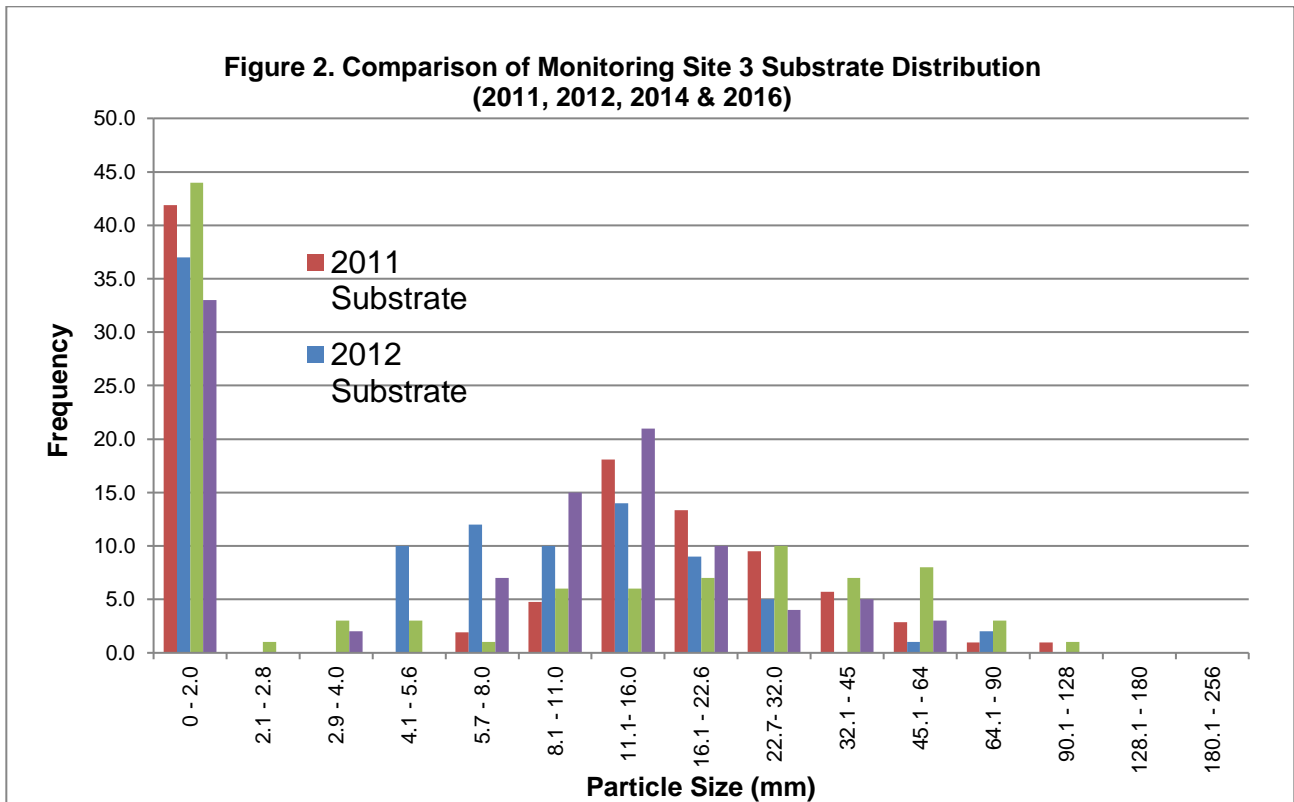
Substrate size distribution for Monitoring Site 3 is shown below in Figure 2.

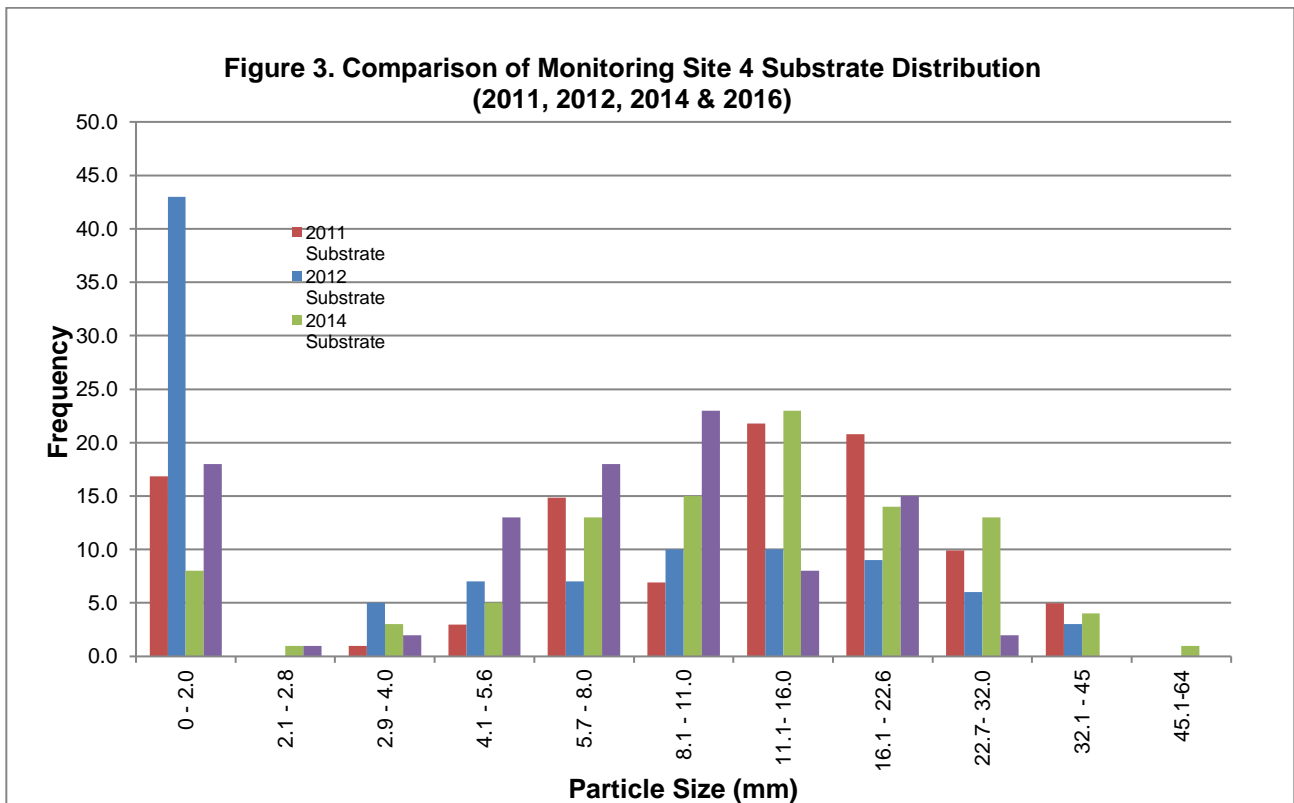
Substrate size distribution for Monitoring Site 4 is shown below in Figure 3.

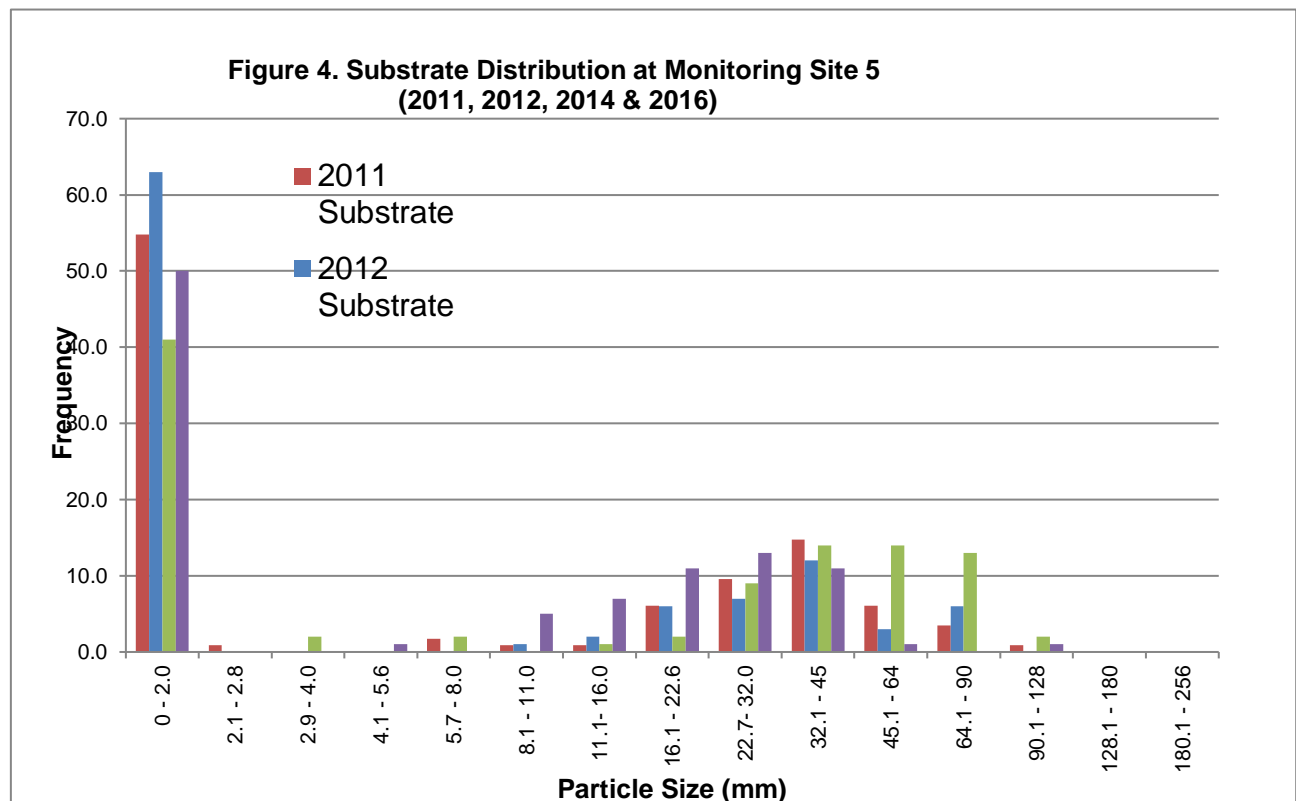
Substrate size distribution for Monitoring Site 5 is shown below in Figure 4.

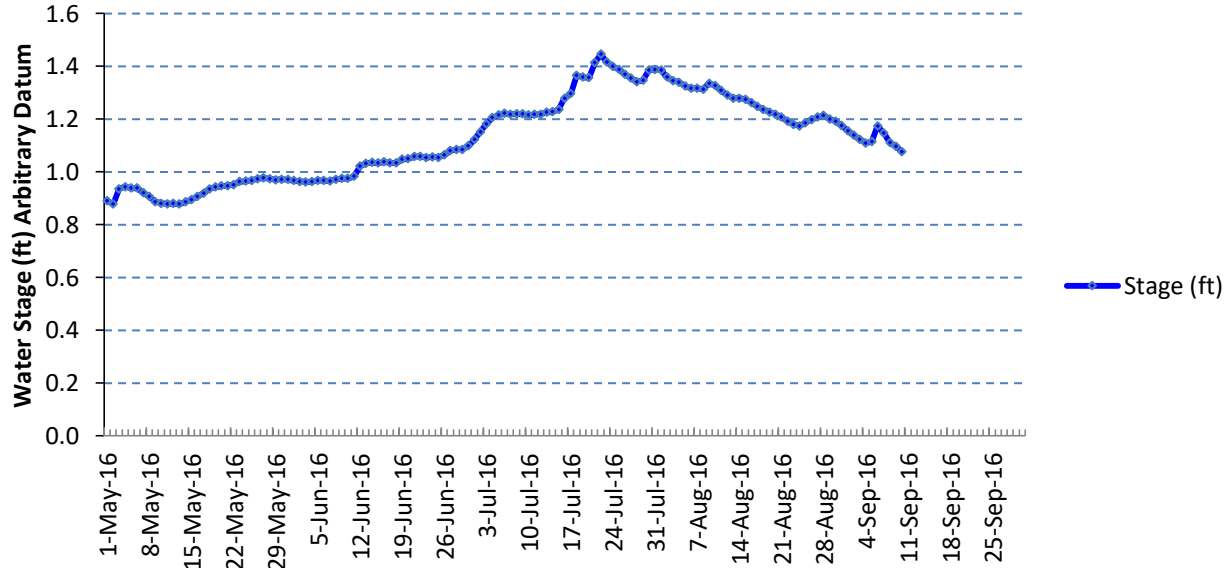
Water stage data recorded at the Piledriver Slough gage over the course of the 2016 field season correlates well with the Tanana River gage at Fairbanks for the same period of record (Figure XX, Appendix C). At both gage stations flows largely increased from about May 12 through late July. Peak flows occurred July 21-22 and generally declined from late July through September. Although stage data for the USGS Chena River below Moose Creek Dam gage shows peak flows also occurring in late July there is not a strong correlation between the 2016 Chena River gage record and 2016 gage records for Piledriver Slough or Tanana River.

Figure C-1. Daily average water stage for Piledriver Slough stream gage at monitoring Site #4 near Xanthus Way bridge crossing, May 1 through September 10, 2016.

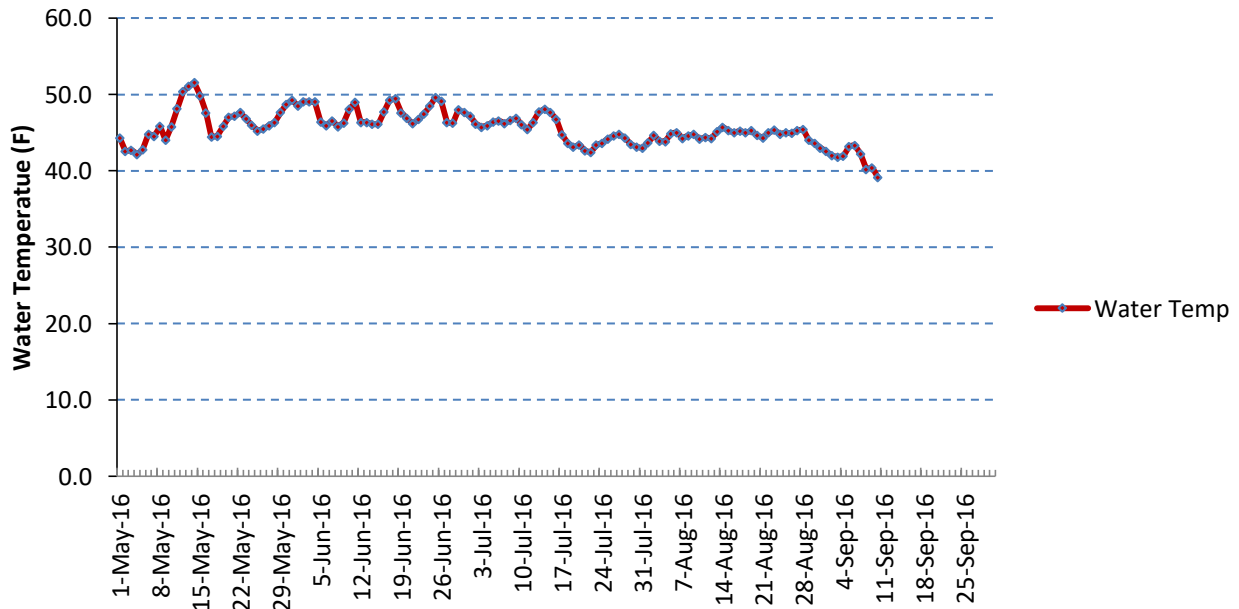
Figure C-2. Daily average water temperature for Piledriver Slough stream gage at monitoring Site #4 near Xanthus Way bridge crossing, May 1 through September 10, 2016.

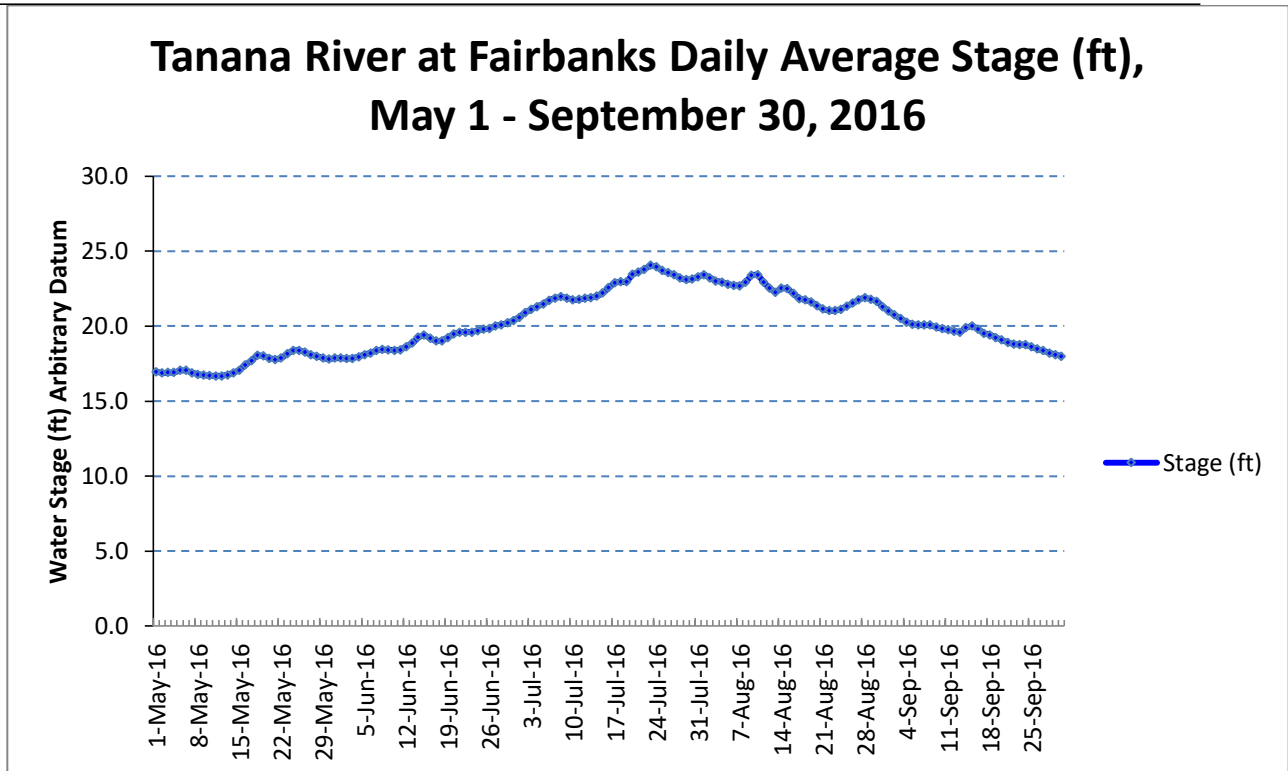
Figure C-3. Daily average water stage for USGS Tanana River at Fairbanks stream gage #15485500, May 1 through September 30, 2016.

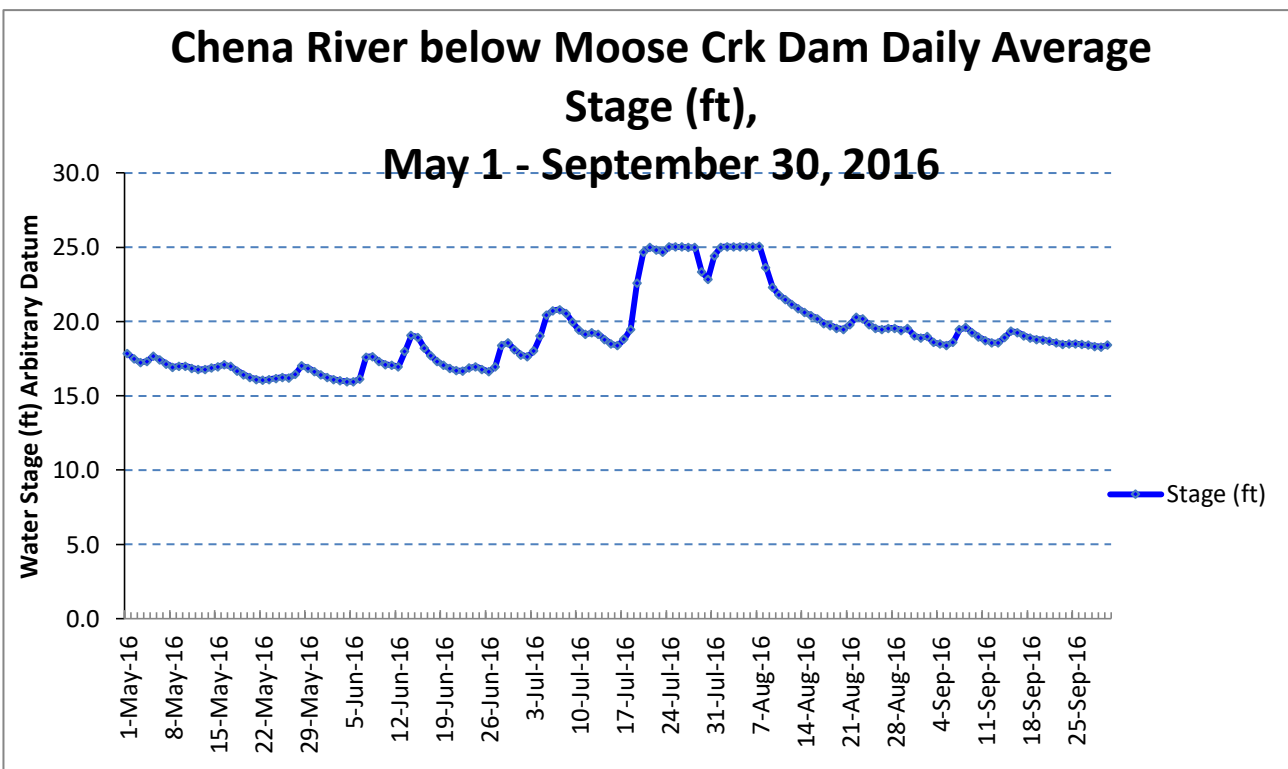
Figure C-4. Daily average water stage for USGS Chena River below Moose Creek Dam stream gage #15493700, May 1 through September 30, 2016.

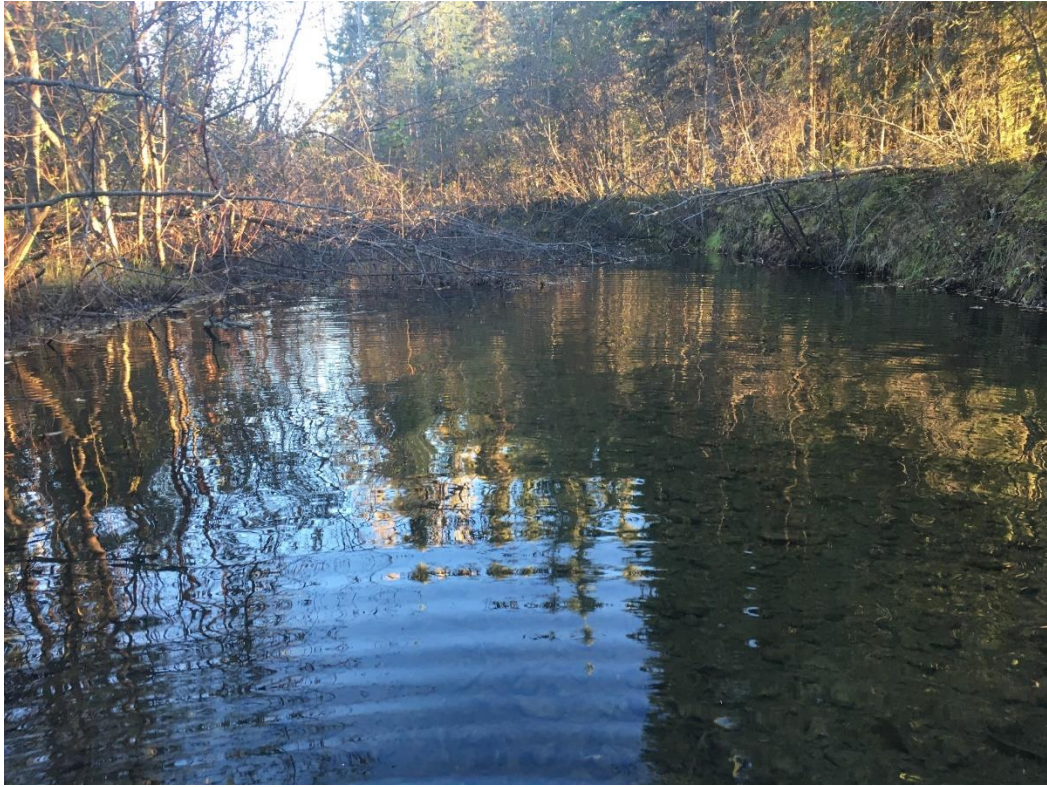
Site 2 September 10th From center of channel looking upstream (south)

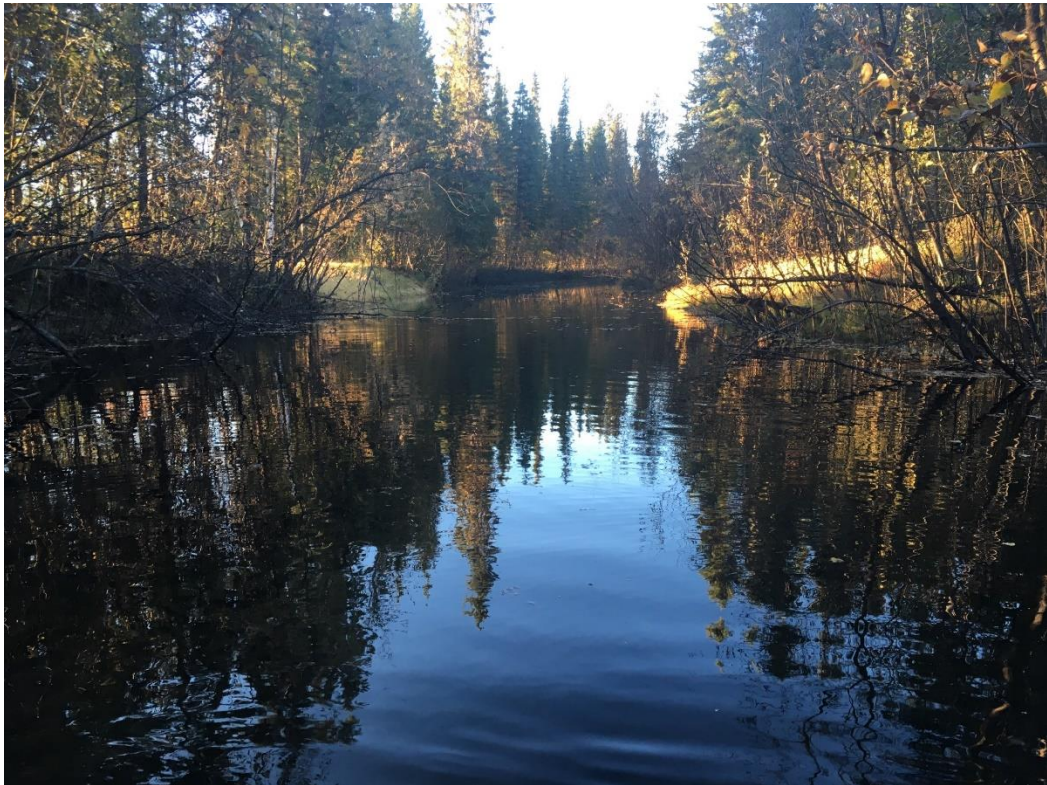
Site 2 September 10th From center of channel looking downstream (north)

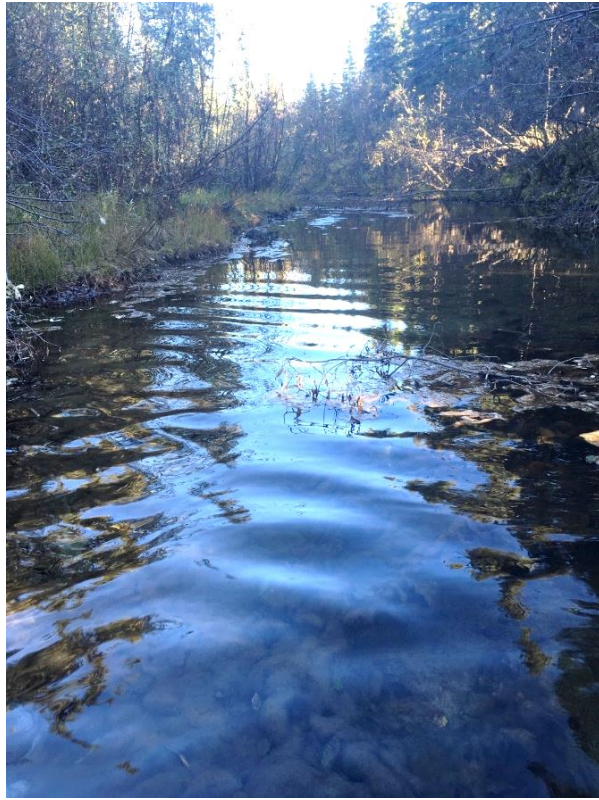
Site 3 September 10th From center of channel looking upstream (south)

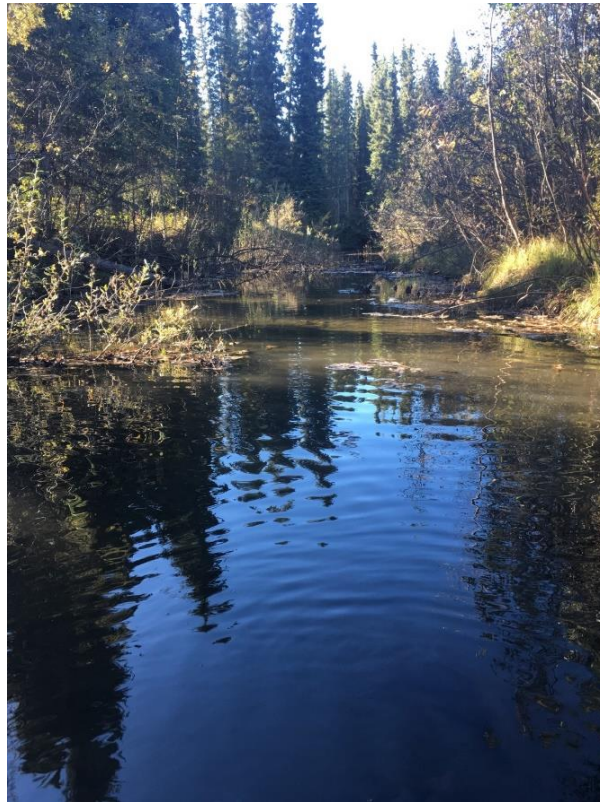
Site 3 September 10th From center of channel looking downstream (north)

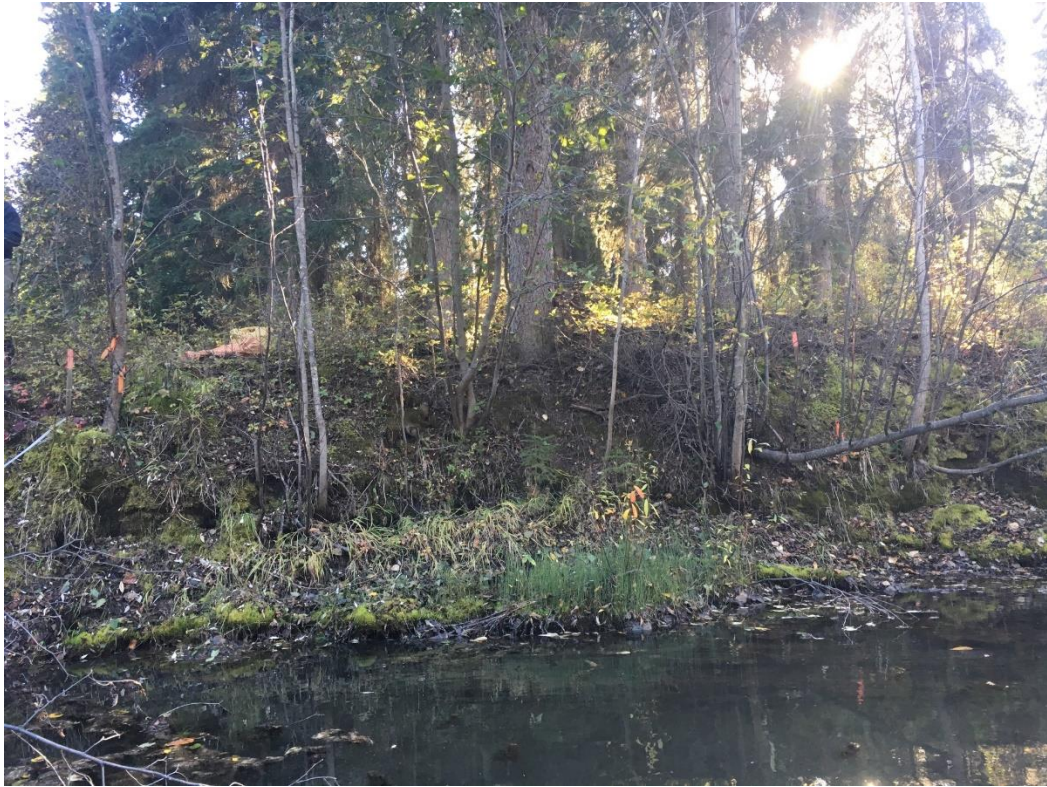
Site 3 September 10th Left (west) bank from center of transect

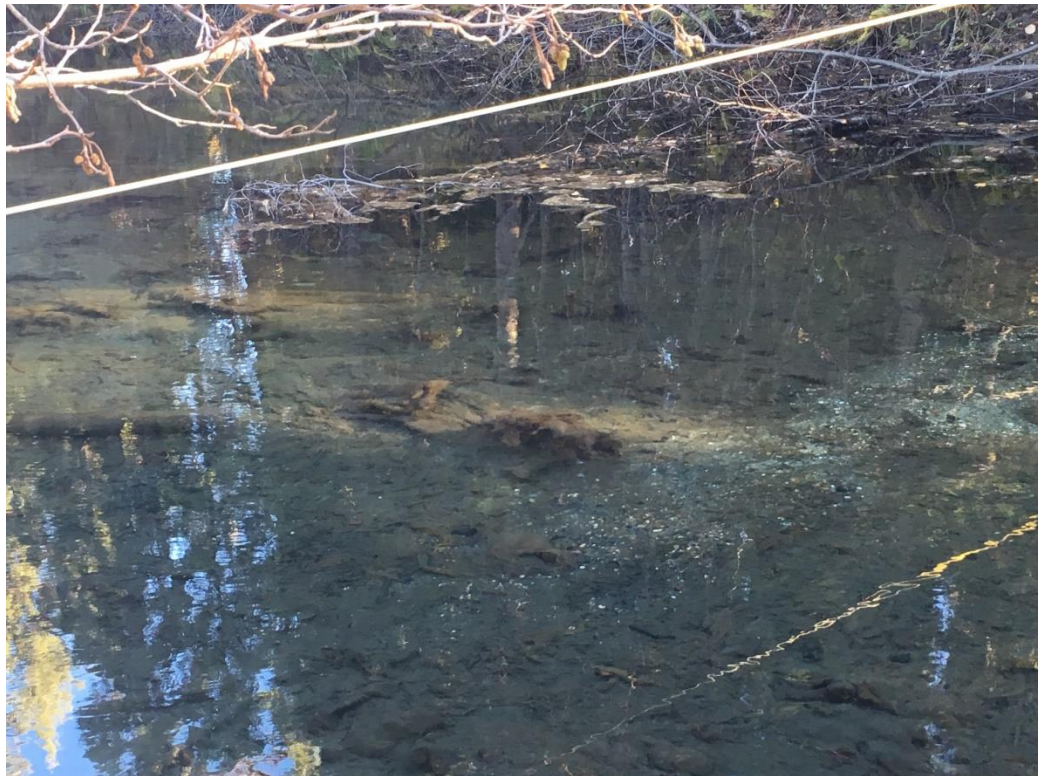
Site 3 September 10th Algae growth on streambed

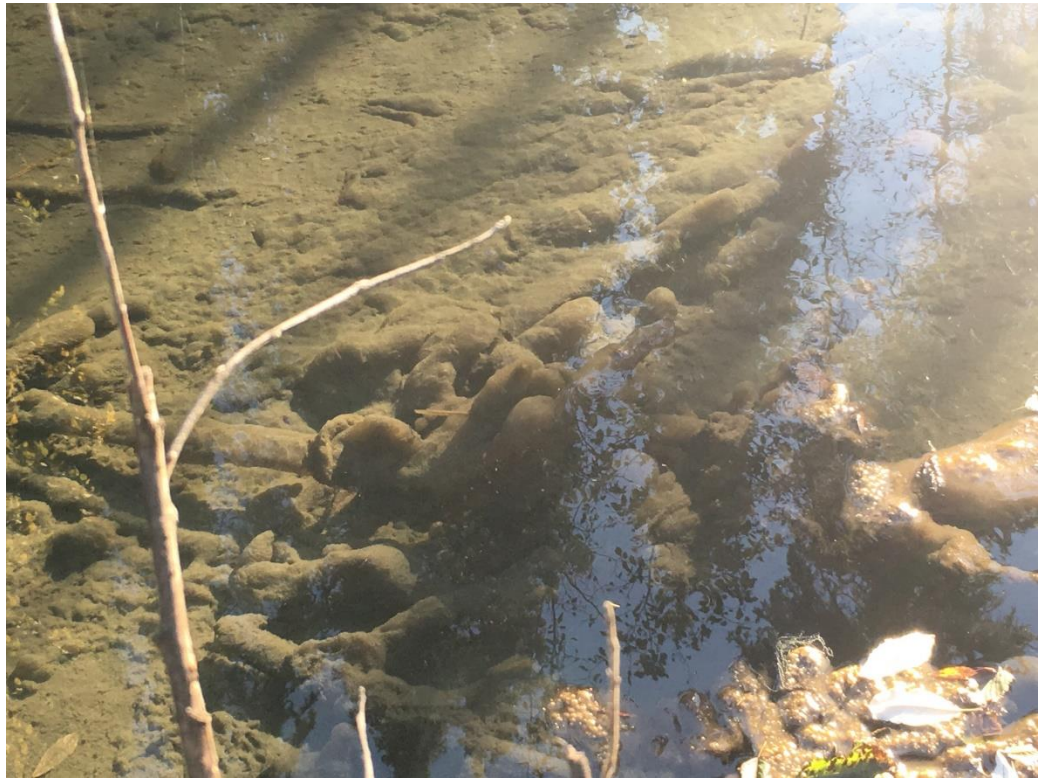
Site 3 September 10th Algae and large woody debris

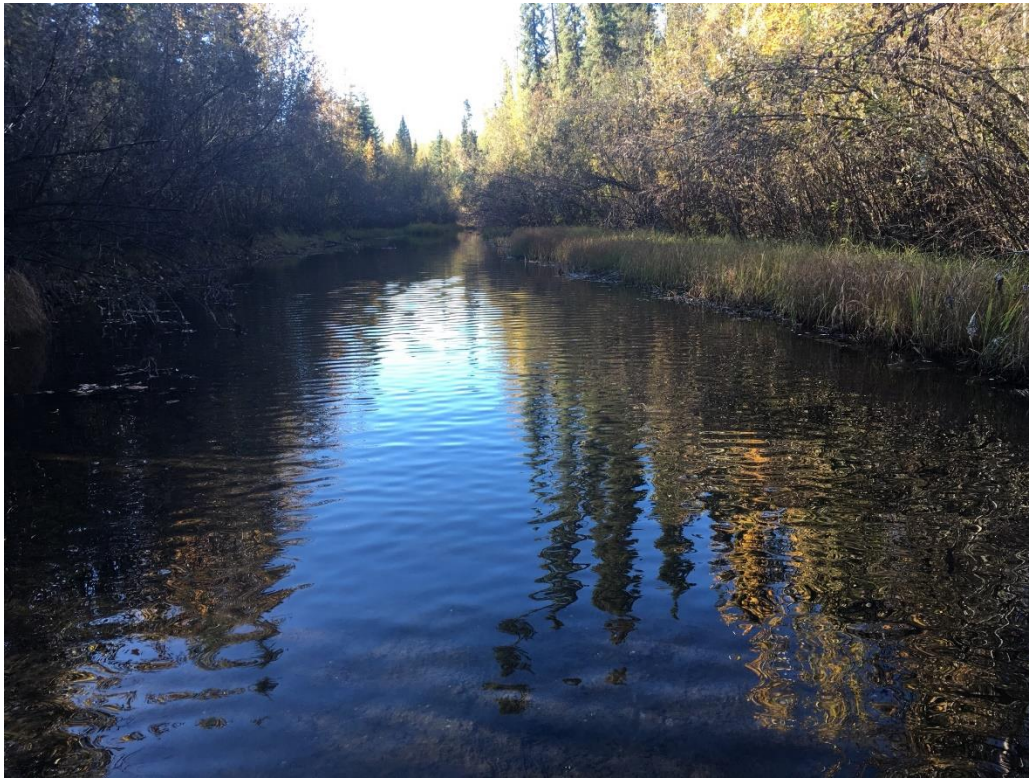
Site 4 September 10th From center of channel looking upstream (south)

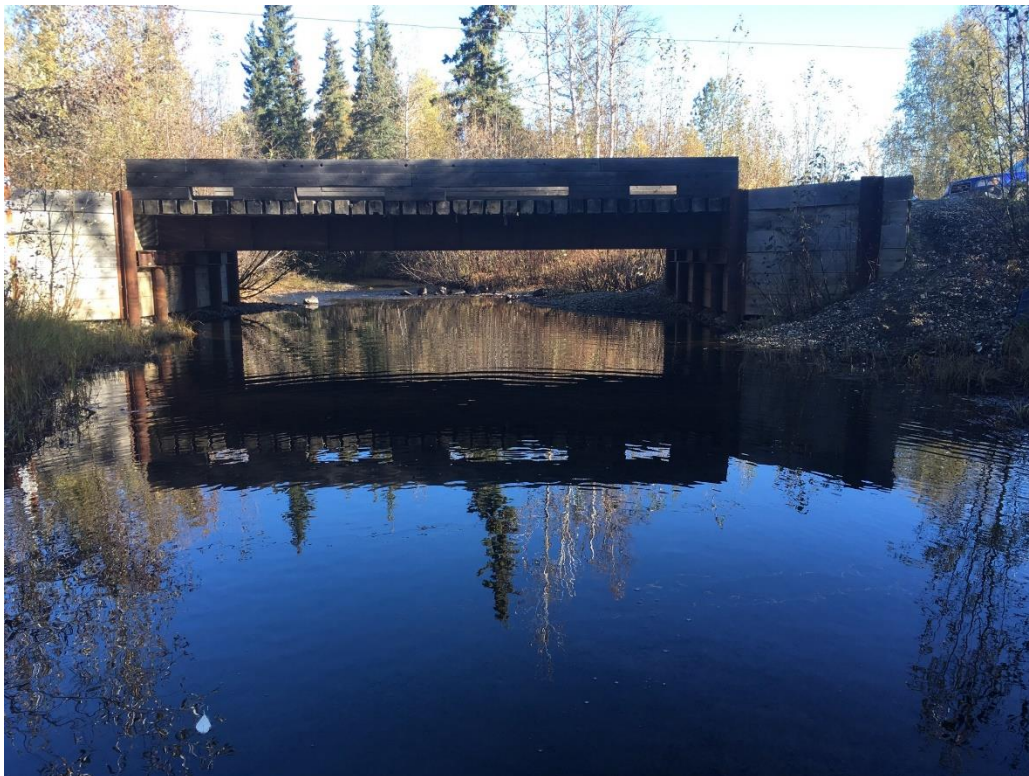
Site 4 September 10th From center of channel looking downstream (north)

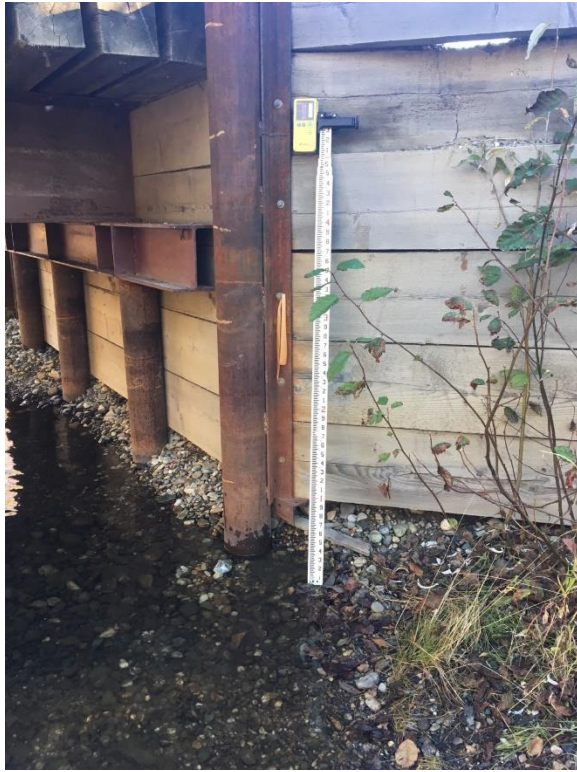
Site 4 September 10th Benchmark on bridge right (east) abutment, upstream side

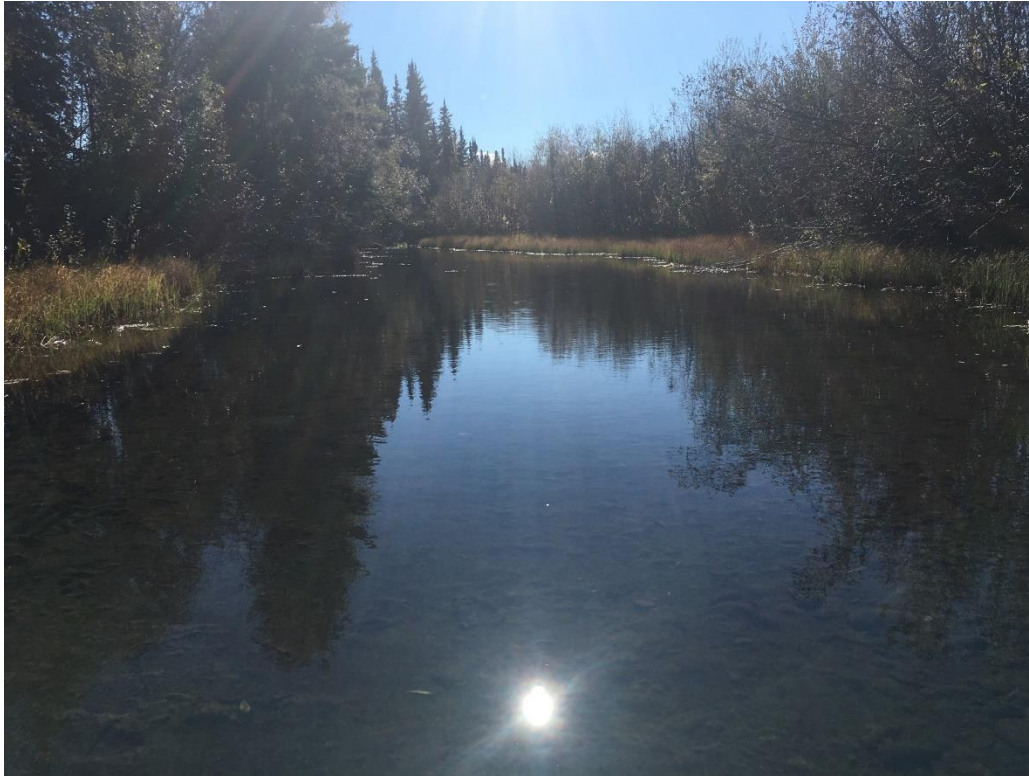
Site 5 September 10th From center of channel looking upstream (south)

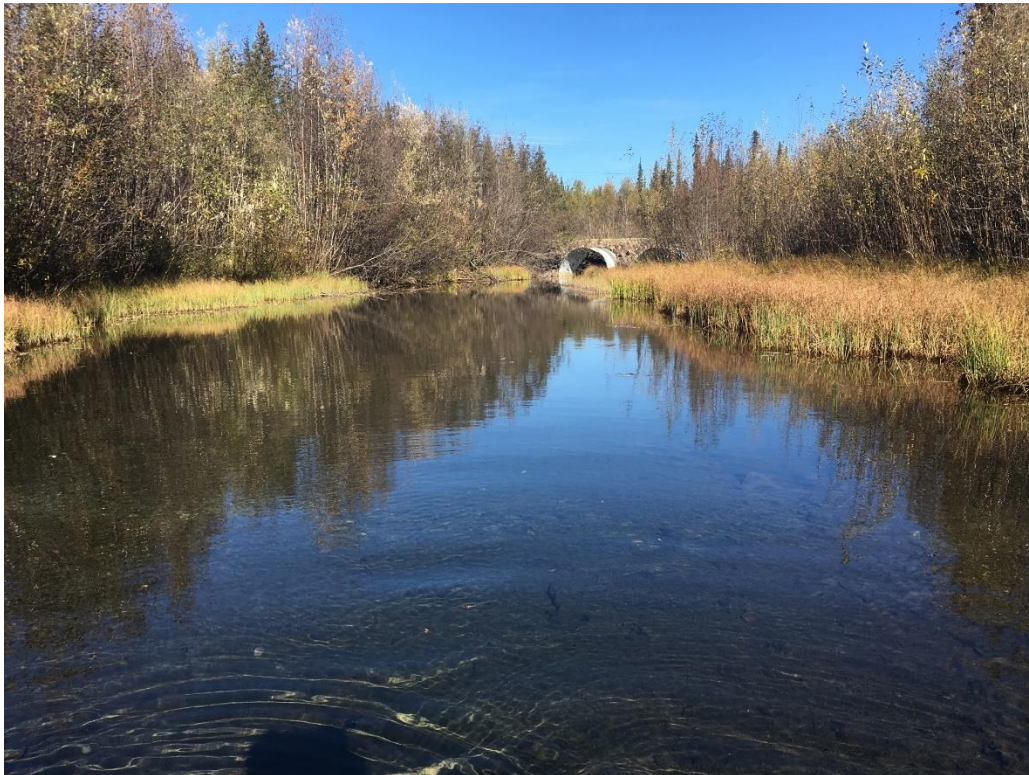
Site 5 September 10th From center of channel looking downstream (north)
