Piledriver and 23 Mile Slough Survey Report 2019

Tanana Valley Watershed Association

December 23, 2019

Piledriver Slough Beaver Activity Survey Report 2019

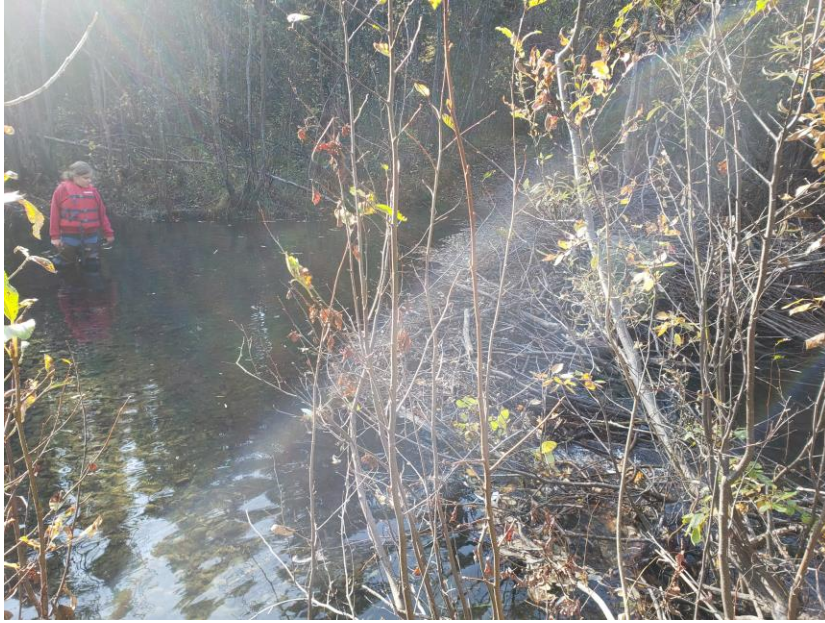
This year there was a new dam at Site 5 on upper Piledriver Slough observed during the September sampling period. This dam caused significant changes to the hydrology of the site, raising the water about 11 inches from normal levels and changing where we could set fish traps. Students from Salcha Elementary were eager to explore this major change to the site.

Site 5 dam on Upper Piledriver Slough during September sampling.

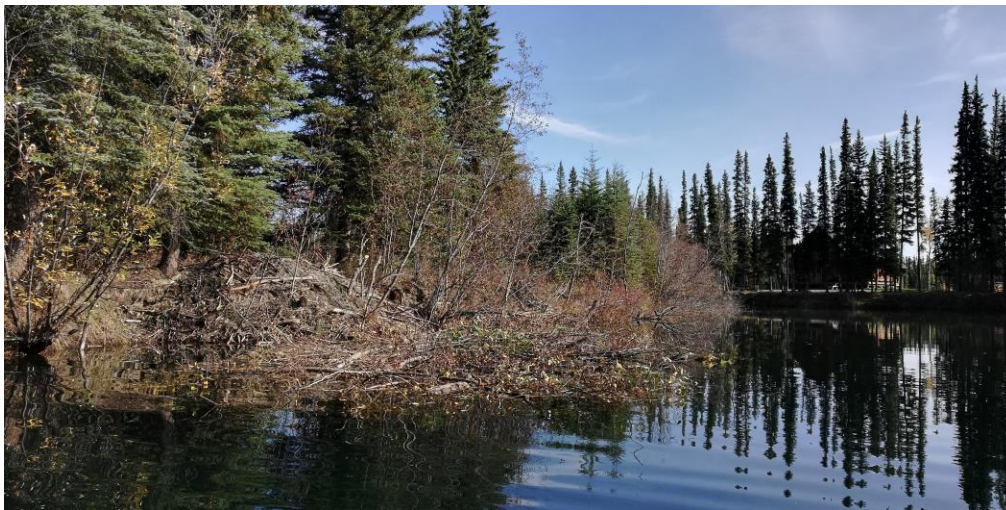
Site 0:

During the September float, TVWA contractors noted that an old lodge site near the Cady's property was clearly being inhabited. A large food cache stocked full of fresh alder, willow, and birch indicating that the beavers will over-winter at this lodge again this winter.

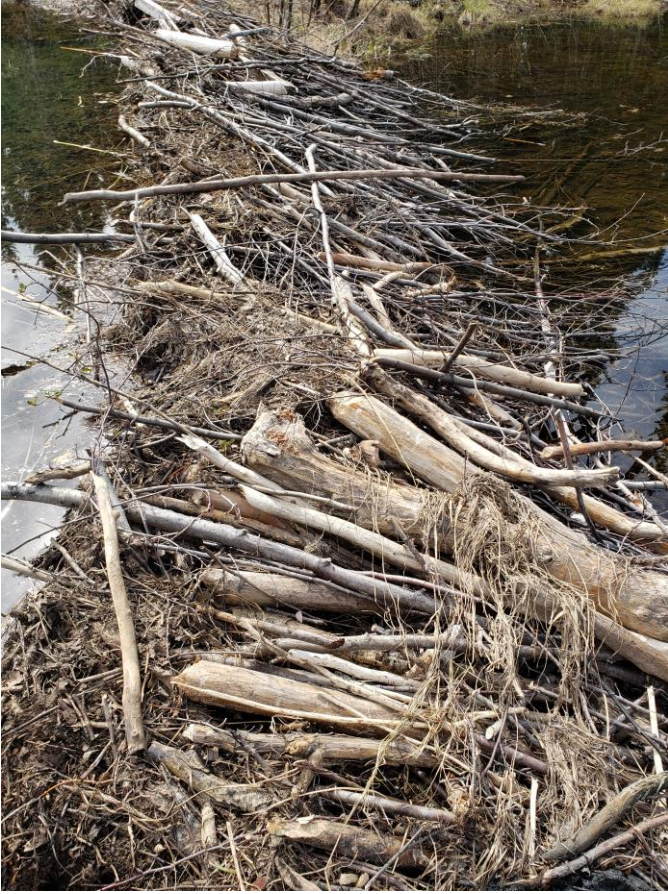
A primary dam was found downstream of the lodge at site 0 and Alan Cady's property. This dam ranged from 2-3 feet tall and blocked all passage during May, June and September floats.

Site 1 during May sampling.

The location of the problem dams, site 1 and 2, are close (1/2 mile approximately) to the uppermost limit of the observed spawning area (by the Barnes' property). Without removing or killing the beavers, there was little point in removing the dam as it would be swiftly rebuilt. TVWA contractors made a small breach during June sampling to the primary and secondary dams. We will continue to correspond with ADF&G, the Railroad and Mr. Cady about this dam issue in the future.

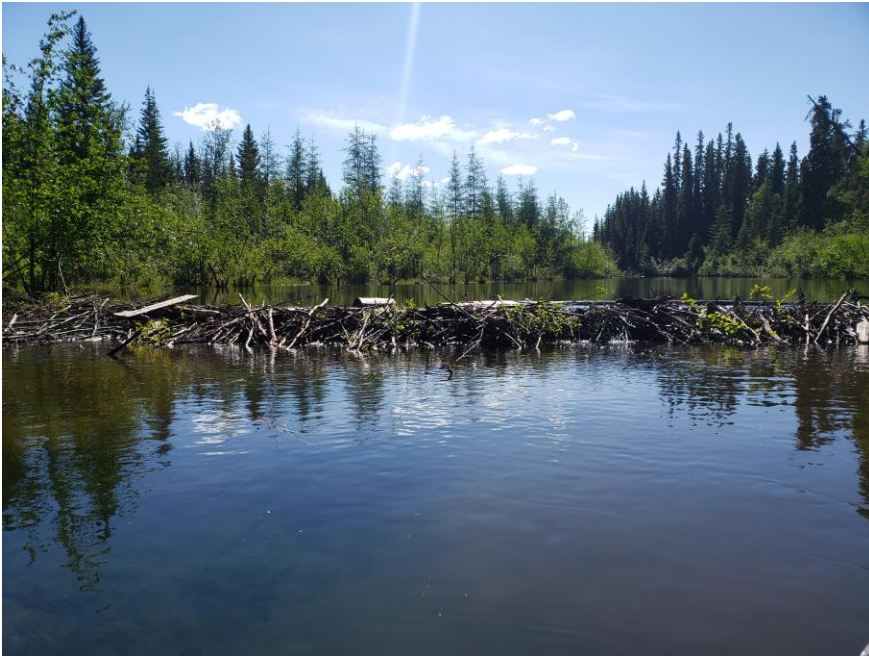
Site 1 during June sampling.

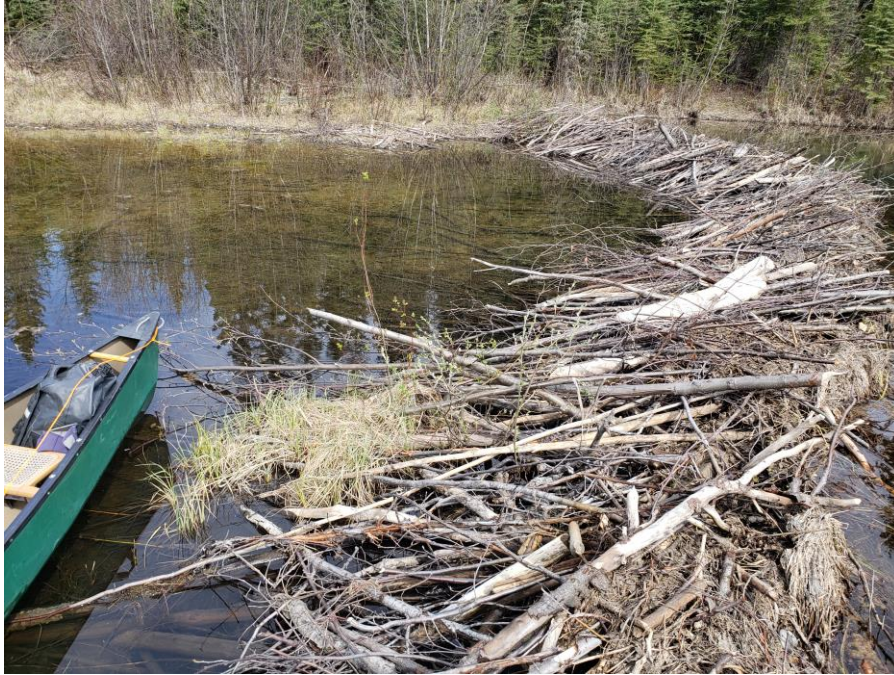
This is the secondary dam associated with site 1 dam. It was observed during all 3 floats as blocking passage in 2019.

Site 2 during May sampling.

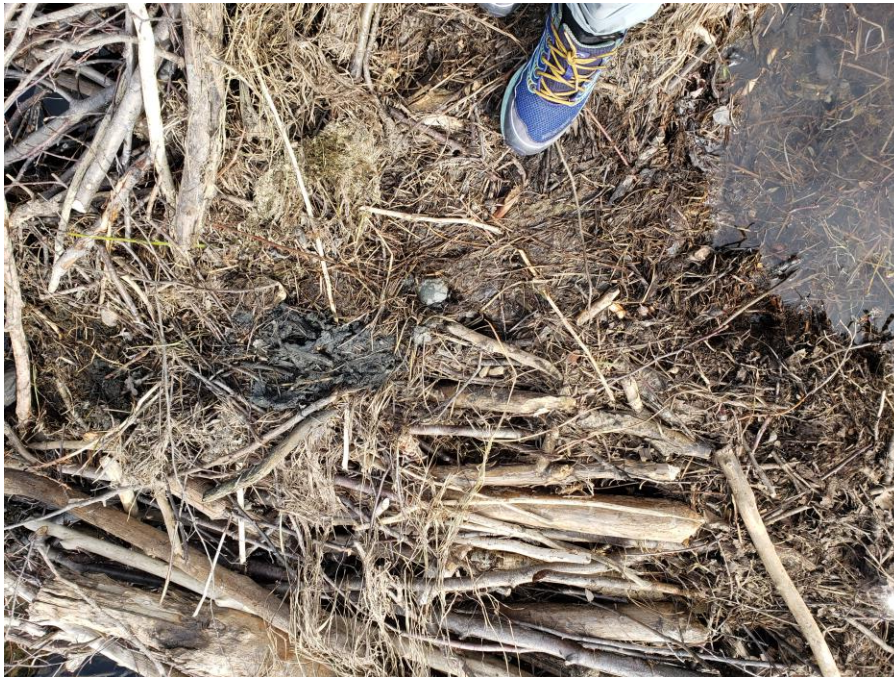
Detail of site 2 including rocks and beaver feces.

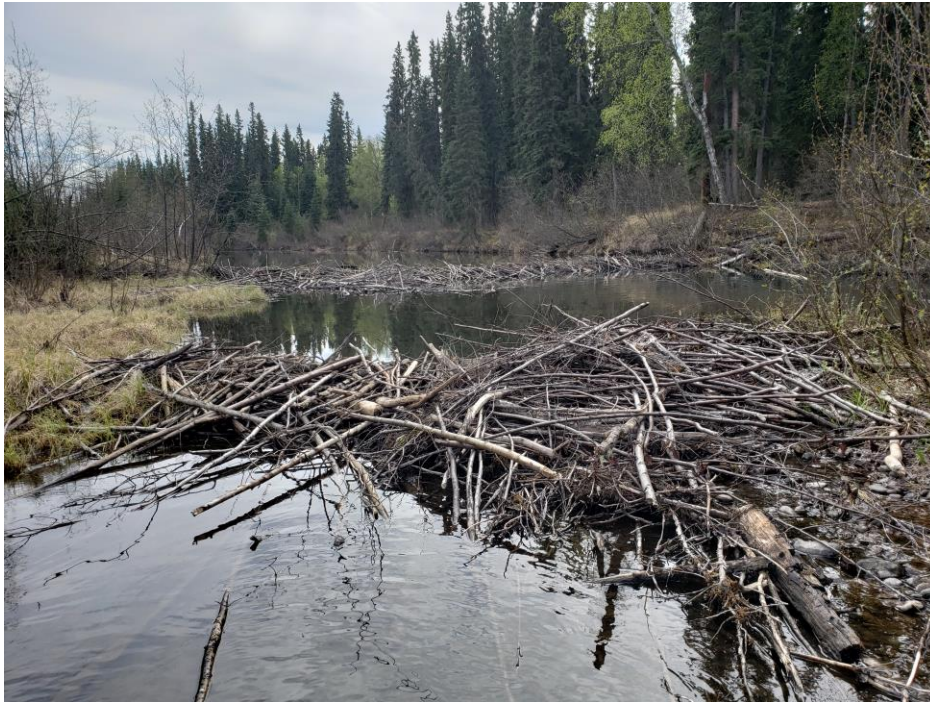
This was a secondary dam located just downstream of Site 2. 2019 was the first year that we have observed a dam at this location. It indicates the spread of the beaver colony in this area.

2019 Dam 1 (foreground) and site 2 (background) during May sampling

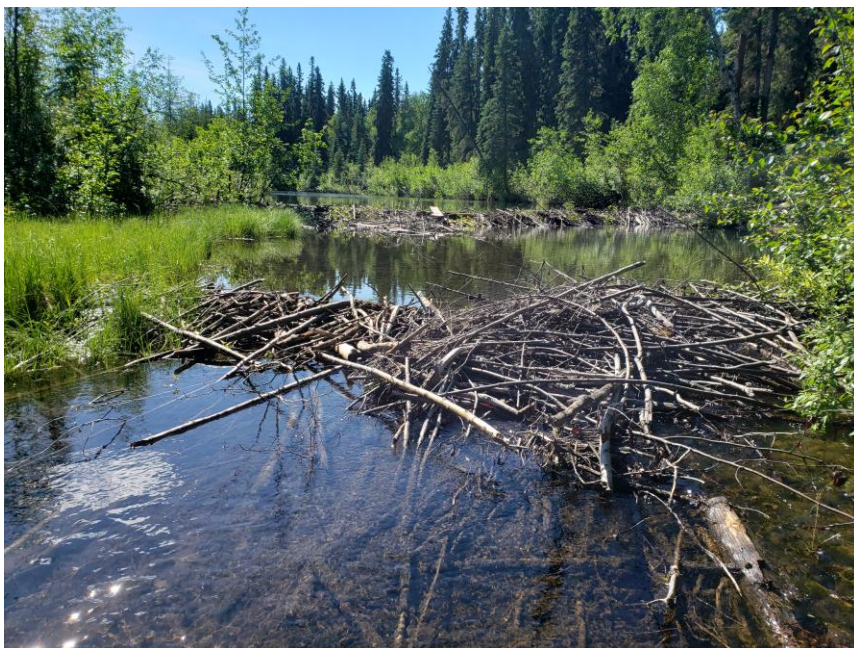
2019 Dam 1 (foreground) and Site 2 (background) during June sampling

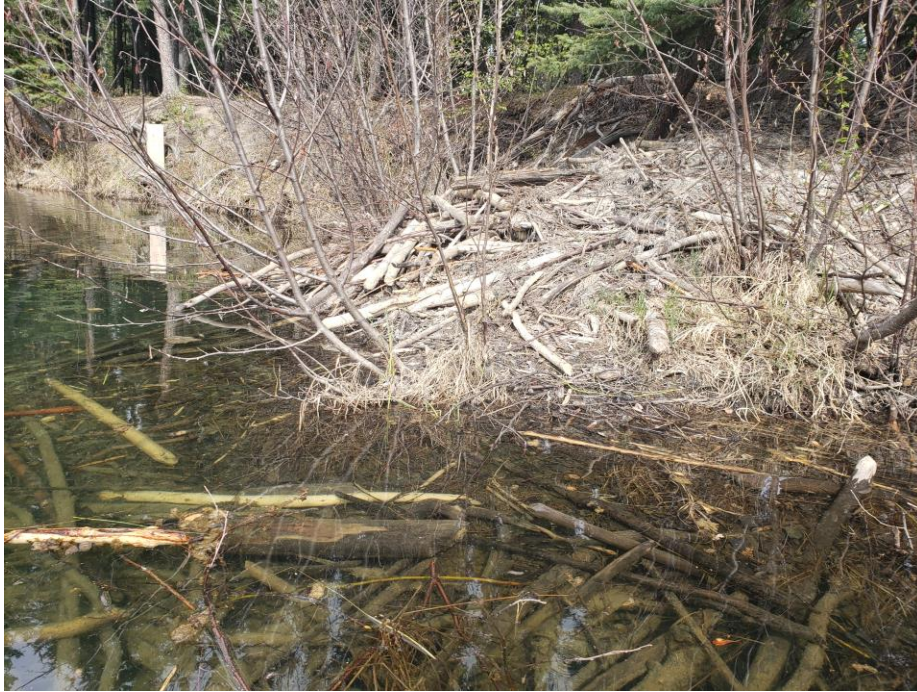
2019 Lodge:

This lodge was noted during September sampling this year. It was a new lodge created in what had possibly been an old site. It was complete with a large feed pile, indicating that the beavers will likely be inhabiting it this winter.

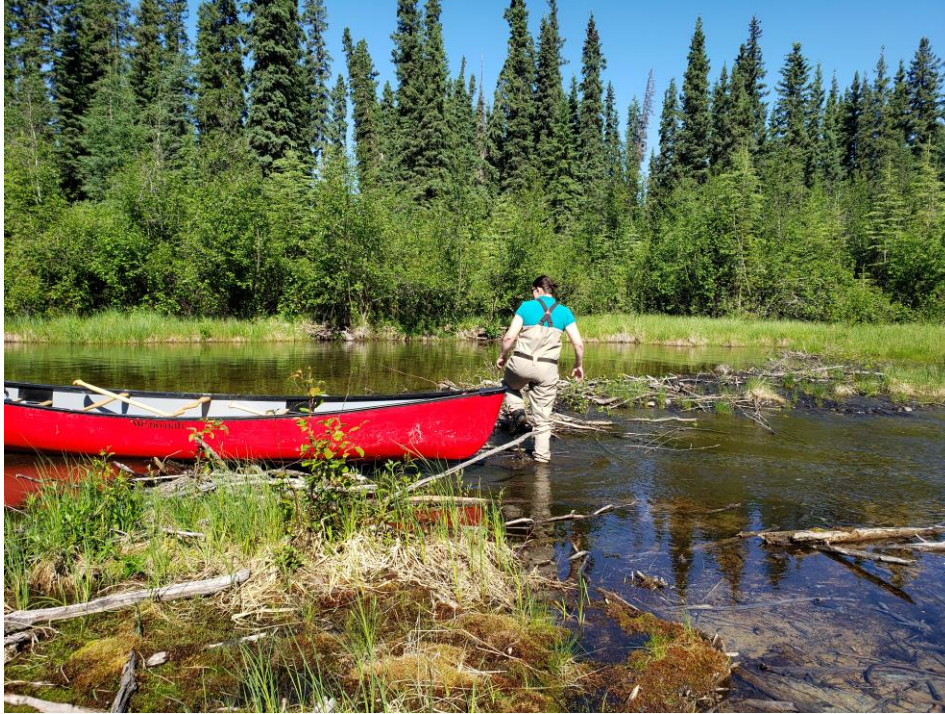
There were a series of old dam sites indicated by remaining rocks and small debris throughout Piledriver Slough. In 2019 we observed some of these sites being reclaimed and added to. This is the case with 2019 Dam 2. It was first observed during June sampling when water was lower but was added to in September. The dam was not blocking passage completely during either sampling but will be monitored.

Part of 2019 Dam 2 during June sampling.

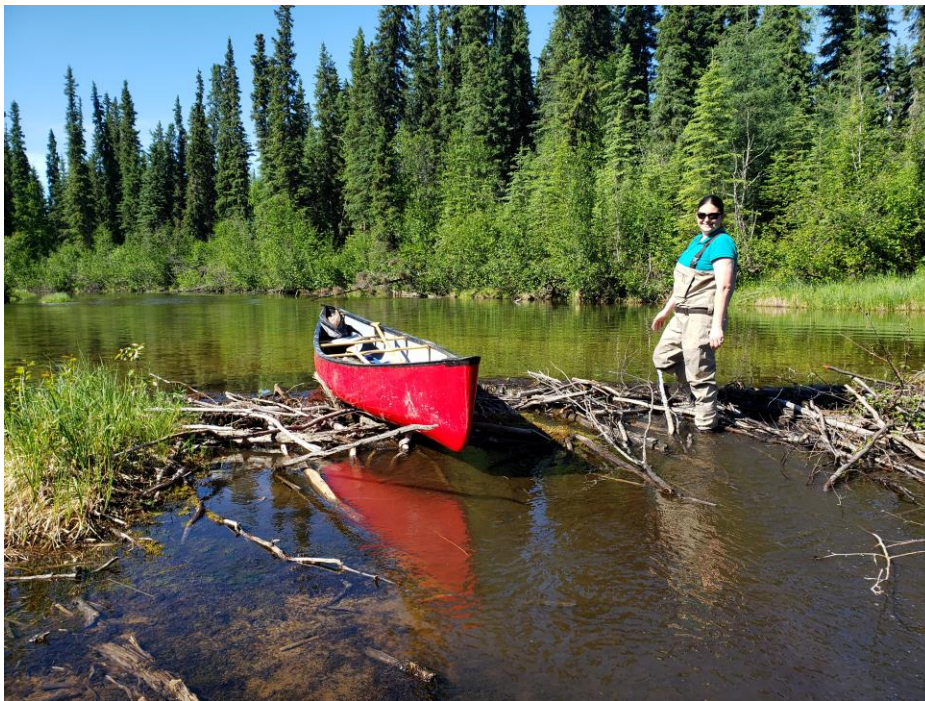
Another section of 2019 Dam 2 during June sampling

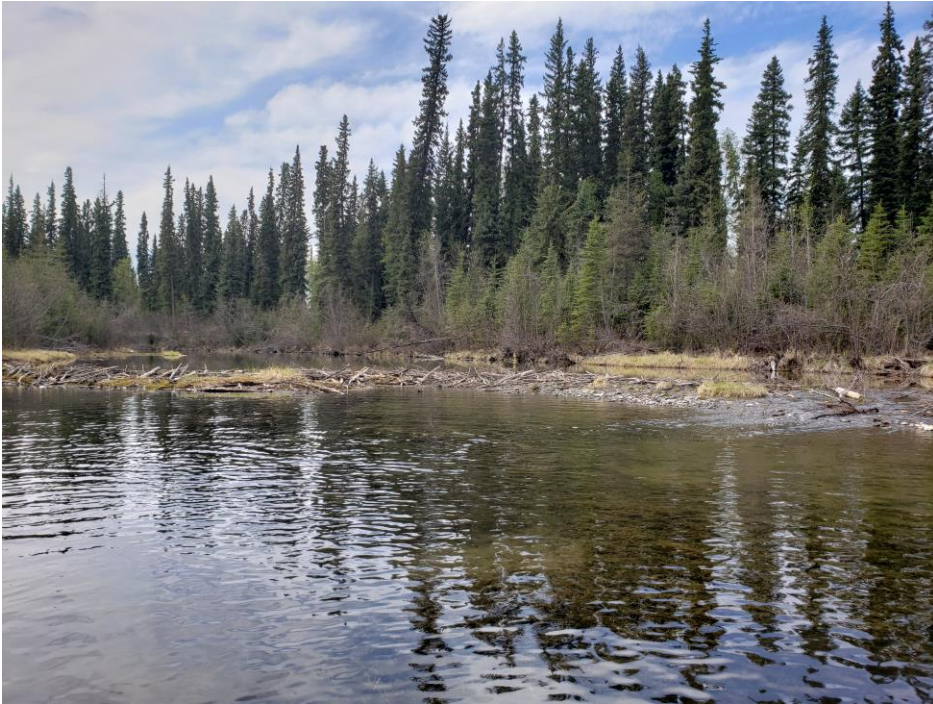
This dam is much farther down Piledriver slough than the first two. We observed that it grew from May to September sampling dates. It is at a natural narrow spot in the slough and was

observed blocking passage completely during all sampling periods. We punched a small hole in this dam during June sampling.

Site 4 dam during May sampling

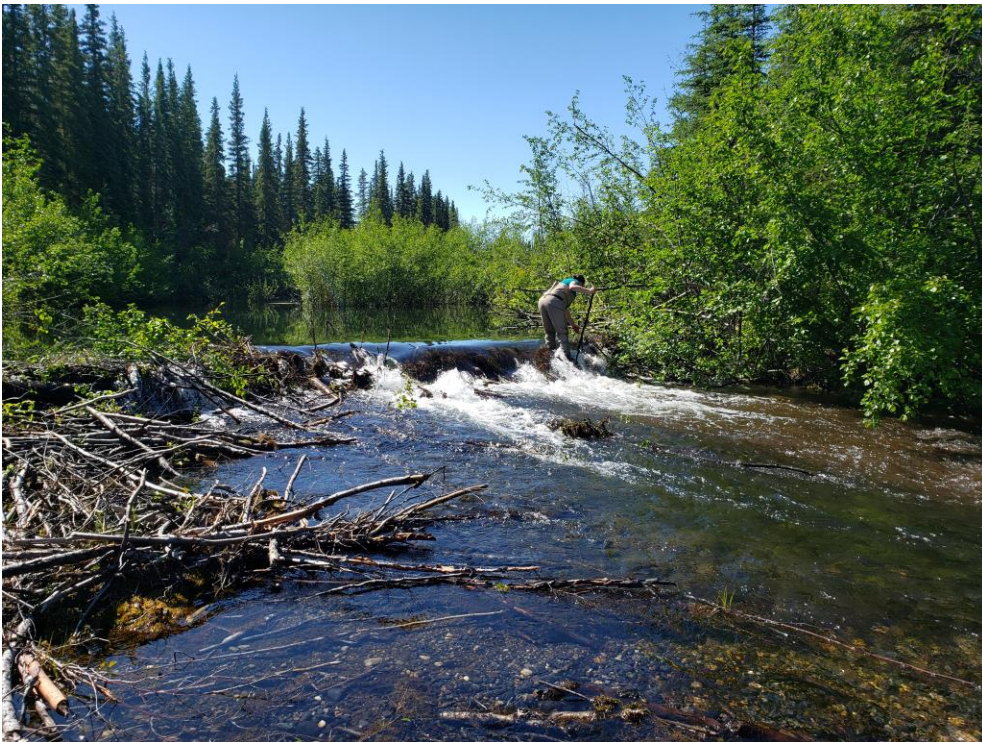
TVWA Science Director Cynthia Nelson making a small breach in site 4 during June sampling.

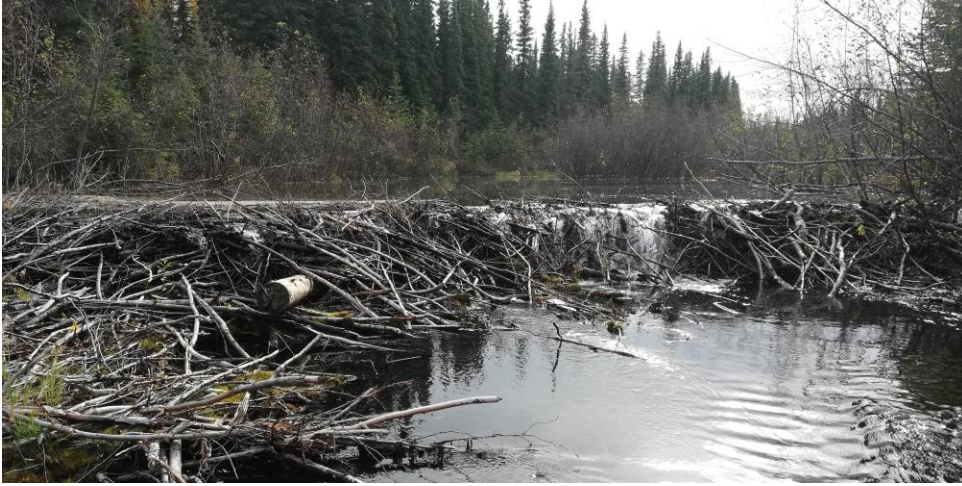
Site 4 was observed in September sampling to be fully constructed and blocking fish passage.
